WALKABILITY ASSESSMENT: CHURCHILL NEIGHBORHOOD HOLYOKE, MA

Our Mission

To provide the City of Holyoke Planning and Development office with a report on the findings of our walkability assessment of the neighborhood in order to identify problems.

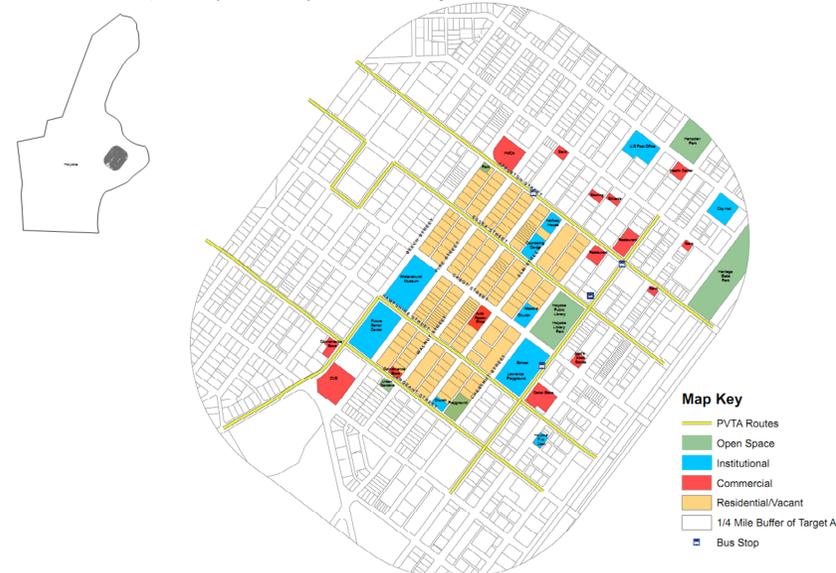
Map B Holyoke Study Area: Meeting Basic Needs and Transit Access

The above map illustrates accessible amenities within the target area, as well as a quarter mile buffer zone surrounding the area. The majority of basic needs are available within the target area and buffer zone. When observing the map it should be noted that there are no grocery stores within the target area or buffer zone and the Lawrence Elementary school is also located just outside the target area.
